# Manhole Inspection Summary

Manhole # S09OO1021MH

Insp Date: **5/18/07 1:28 PM**

**Location** Address: **3323 GARRISON AVE**

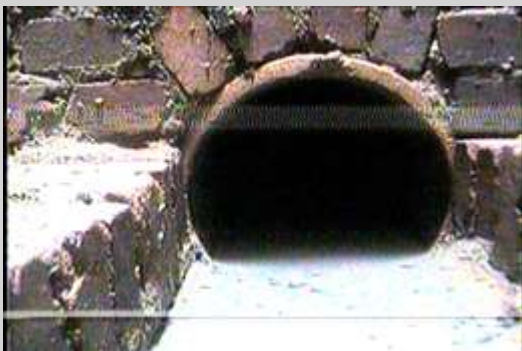
6 O'Clock Inflow

10 in. Circular Gravity Sewer  
Pipe In @ 6 O'Clock

Pipe Height: **9.6** (in.) Rod and Bar (Angled)  
Pipe Material: **Clay** ☐ Pipe Lined  
Invert Depth: **14.78** (ft.) Flow Characteristics: **Slow**  
Deposits: ☒ None ☐ Mud ☐ Sludge ☐ **Debris** ☐ Grease  
Silt Depth: (in.) Deposits Extent:  
Infiltration: **None** Pipe Seal Cond: **Sound**
